<b>Project Name:</b> Gold King Mine	<b>Site Location:</b> Silverton, San Juan County, Colorado	<b>Project No.</b> 0001/1408-01
--	---	------------------------------------

## PHOTOGRAPH LOG

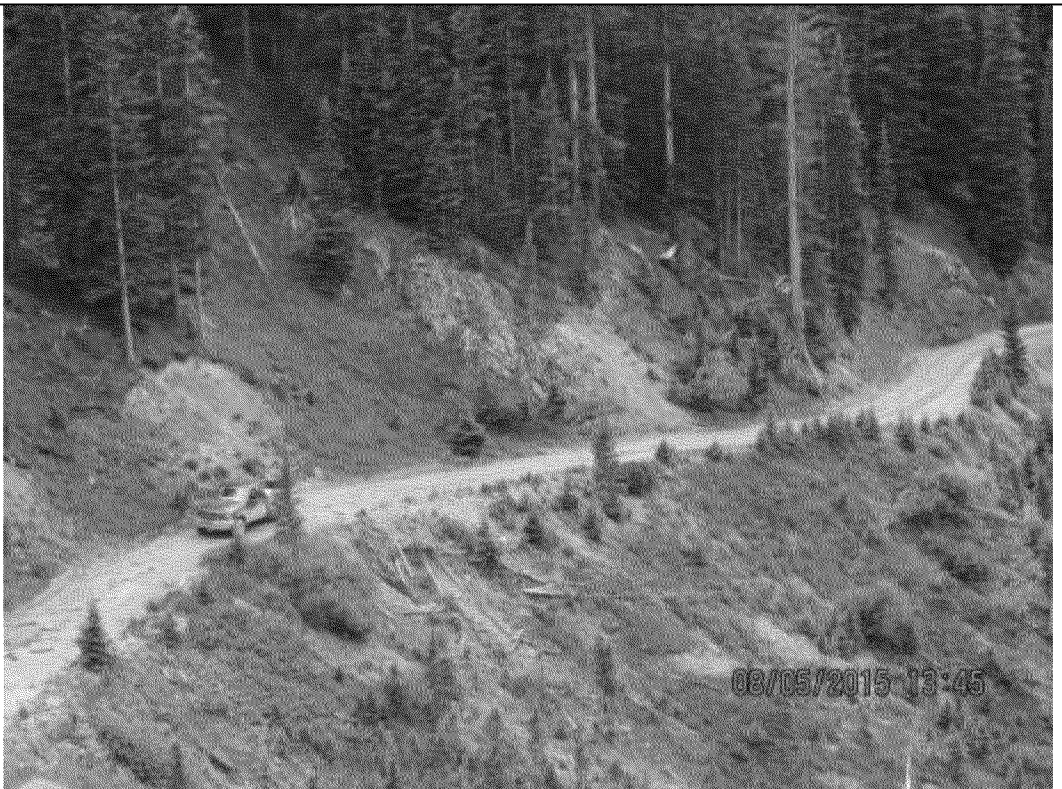
<b>Direction Photo Taken:</b>  Southwest/Down		
<b>Description:</b> Visitor leaving.

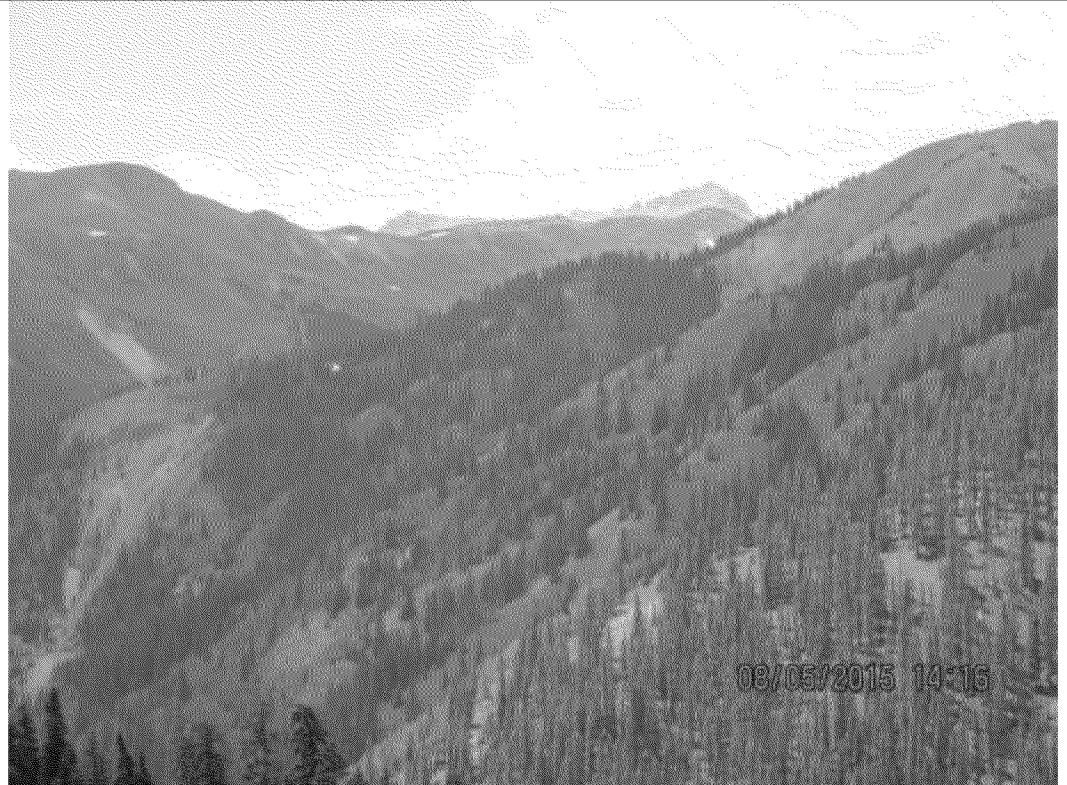
**Photo No.**  
**46**

Flight for life Helicopter coming up the valley to pick up a person who crashed a vehicle on Corkscrew Pass, not related to this event.
